# 12 Years of Residential ‘Off-Grid’ PV Hybrid System Operation and Evolution in Nemiah Valley, Canada

**Abstract**—Eleven residential off-grid photovoltaic (PV) hybrid power systems have been deployed and operated since 2006 in the First Nation community of Xeni Gwet'in located in Nemiah Valley, Canada. This paper reviews the operation and evolution of three system designs. Notable experiences, lessons learned and challenges with respect to reliable hybrid system operation are discussed. Finally, an example illustrating an observed reduction in winter battery capacity is presented, discussed in detail and the concept of closed loop charging control is introduced.

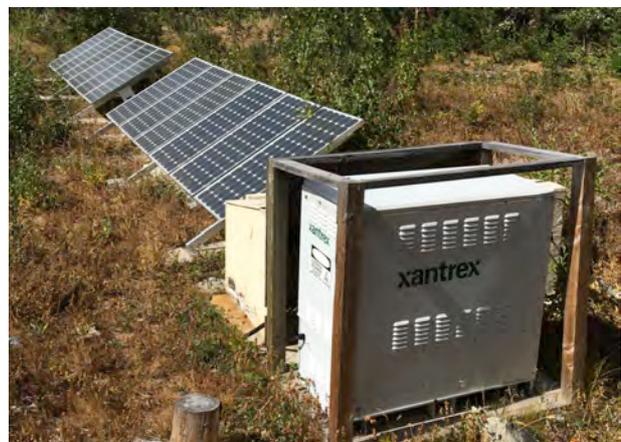
Figure 1. The original 2006 hybrid system in 2017.

The initial PV hybrid system installed in 2006 was dimensioned with a 2 kW<sub>pk</sub> solar PV array and a 48V 400Ah flooded lead-acid battery in order to meet a predicted small 240/120V AC residential load requirement of ~5 kWh/day (Fig. 1). The system was also designed with an integrated enclosure complete with an automatic 5.5 kW propane genset to provide supplemental energy for the low-sun winter season as well as any additional energy generation as

As of 2018 the initial system remains operational and has experienced no hardware failures with the exception of exhausted batteries and genset failure. The batteries have been replaced at least twice and the system is on its third propane genset. As of August 2017 the system has provided 13210 kWh according to the pay-as-you-go smart meter infrastructure installed. This corresponds to an average of 3.3kWh per day over the last eleven years and likely corresponds to ~5kWh per day while residents were at home.

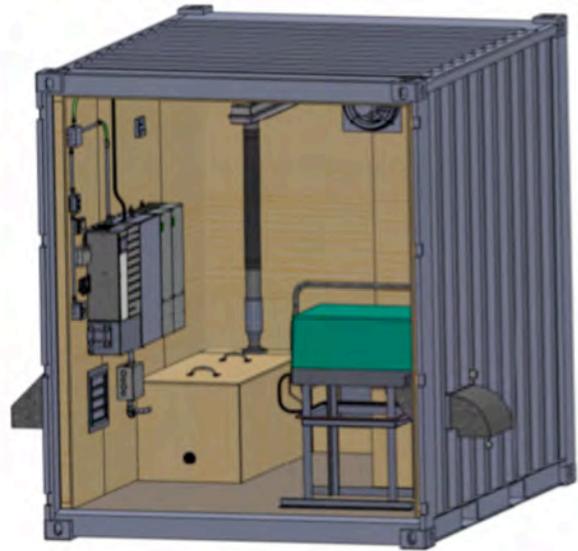
Figure 3. New Containerized Design - 2017

As part of a larger overall electrification initiative within the community seven new hybrid systems were commissioned for delivery in 2017. With the assistance of HOMER software the systems were designed for an 85% PV fraction and 150 genset operating hours per year. The design consisted of 6 kW<sub>pk</sub> of PV, 1000Ah of flooded lead-acid batteries and the same 5.5 kW propane genset as used previously. The design load was 15 kWh/day. The components were then engineered into a robust 10' shipping container as presented in Fig. 3. The shipping container provides ease of service in addition to providing a secure and protected enclosure. The container features voltage controlled exhaust fans on the battery boxes. A

secondary hydrogen alarm system evacuates the entire container with a main exhaust fan if hydrogen concentrations exceeds dangerous levels within the container. Finally, the container features a thermostatically controlled propane furnace to designed to be used in extreme cold conditions. The updated power conversion equipment also features a remotely accessible web-based interface, which enables the system to be remotely monitored and configured. The monitoring system also has the capacity to log system energies as discussed in the previous section to allow for rapid performance assessment.
